Vintage Timber Truss Roofs: Claims Waiting to Happen

By David B. Tigue and Kurt R. Hoigard

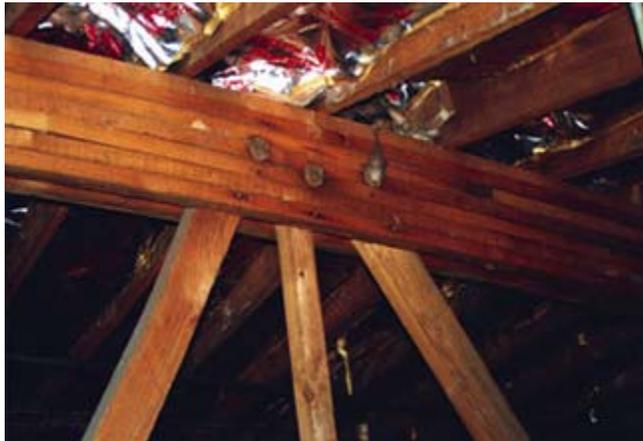
A variety of timber roof truss configurations have been used over the years. One of the most common types is the bowstring truss, so called because of its arched top chord profile (see Figure 1). Roofs constructed with bowstring trusses became popular in the late 1930s, and are readily identified by their curved shape. Although several

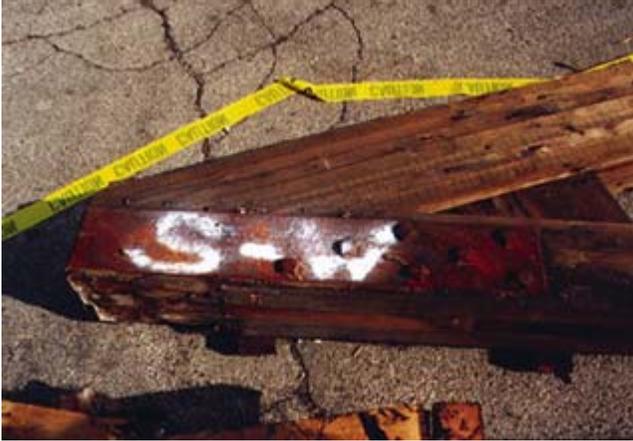
construct both the top and bottom chords with two parallel members. In this arrangement, the web members were sandwiched between the chords and connected with bolts (see Figure 2).

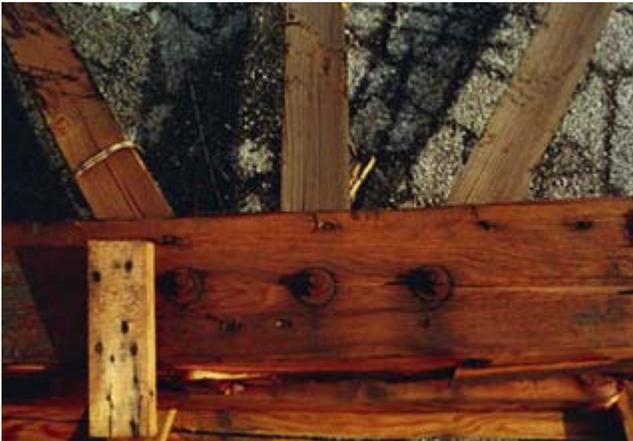
located near mid-span, to achieve the required length. The top and bottom chord members were fastened together at the truss ends with U-shaped steel heels, or end shoes, bolted to both chord members (see Figure 3).

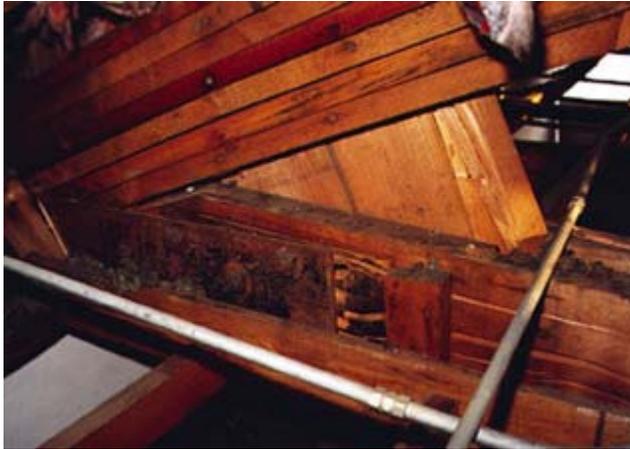
higher than those anticipated by the original designer, and frequently result in connection splitting failures that ultimately endanger the entire truss (see Figure 4).

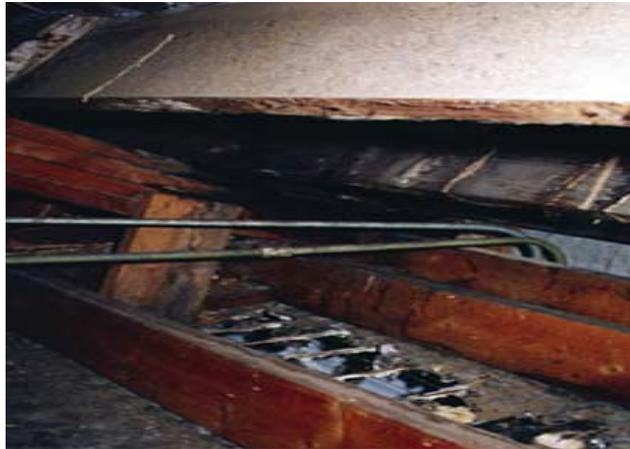
top-chord shortening from crushing against the steel shoe, localized sagging of the bottom chord, and elongation or splitting of the end shoe bolt holes (see Figure 5). Long-term deterioration of truss ends often results in failure of these connections and consequent loss of truss action. When the end connections deteriorate or fail, the outward thrust from the top chord is no longer resisted by the bottom chord. Instead, thrust loads push outward against the supporting masonry walls, resulting in bowing of the walls and--if left unchecked--complete collapse of the roof.
